Whirley Crane Foundation Work Begins

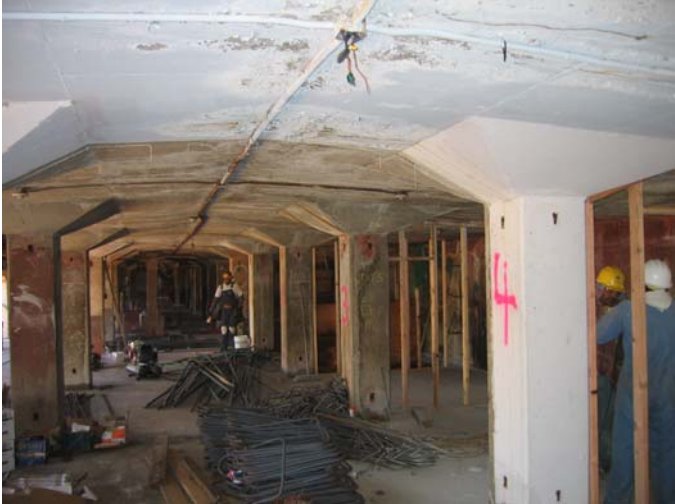
Left - Gallery below area to which Whirley crane will be relocated.

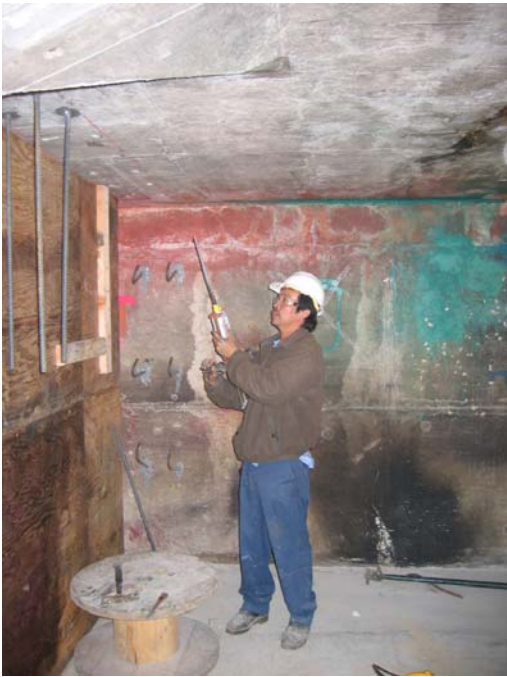
Below left – Insertion of steel dowels into existing concrete with epoxy to anchor new walls and beams.

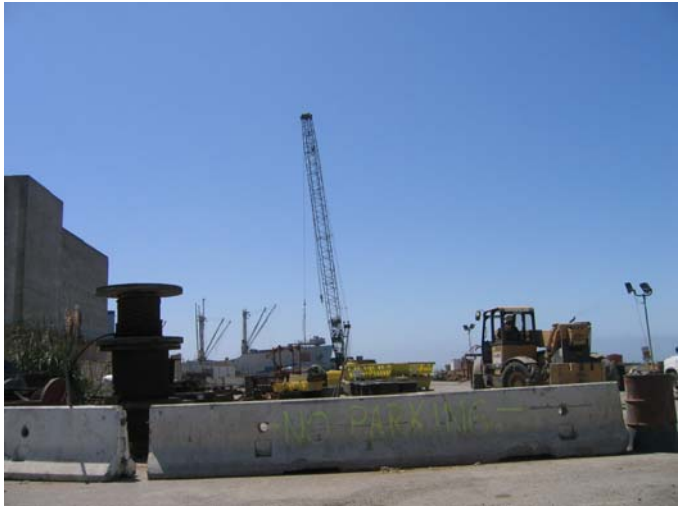
Below – New location of Whirley Crane is just behind the tracked crane, which will be removed

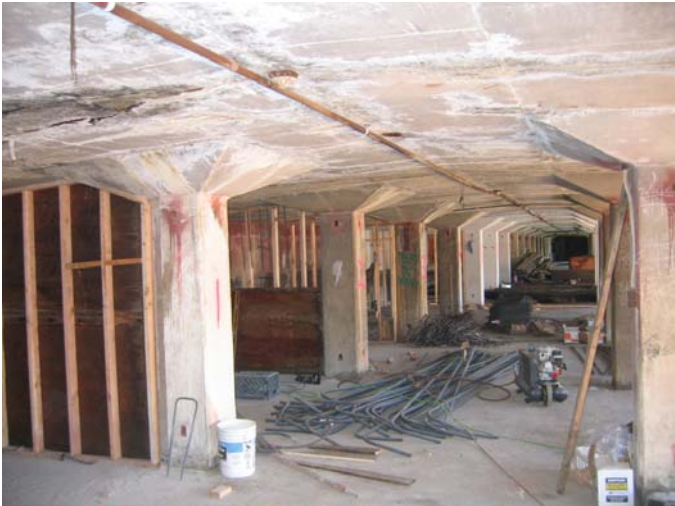
Left – reinforcing steel for new foundation stocked on floor
